ANNEX 3 / APPENDIX 10 EUROPEAN VISUAL INSPECTION CATALOGUE (EVIC) FOR WHEELSETS

European visual inspection catalogue (EVIC) for wagon axles

IMPLEMENTATION GUIDE FOR THE EUROPEAN VISUAL INSPECTION CATALOGUE (EVIC) FOR FREIGHT WAGON AXLES

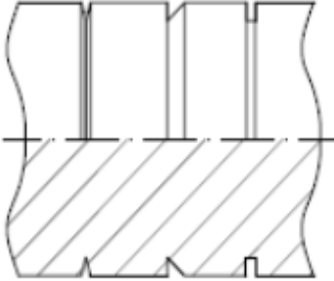
Pictorial representation:

31 Mechanical damage – sharp edged circumferential fluting		Painted axles
Salient information:		
	Flutes are characterised by sharp edged circumferential sharp-edged transitions.	
	Mechanical damage to the base material in the form of fluting is inadmissible.	
Decision:		
	Check on the wagon why this damage could have occurred and repair accordingly	
	Remove from service according	Case A
		X

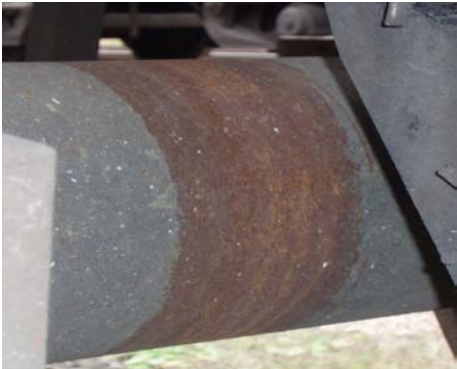
Pictorial representation:

32 Mechanical damage – smooth edged circumferential grooves		Painted axles
Salient information:		
	Characterised by smooth transitions in the edges (GCU Annex 9, 1.6.2). Pitting that arises during operation (caused e.g. by brake lever connectors dragging) involves damaged anti-corrosion coating	
Decision:		
	Check on the wagon why this damage could have occurred and repair accordingly	
	Remove from service	Case B
	if there is damage to the base material > 1mm: (acc. GCU)	Case A
		X

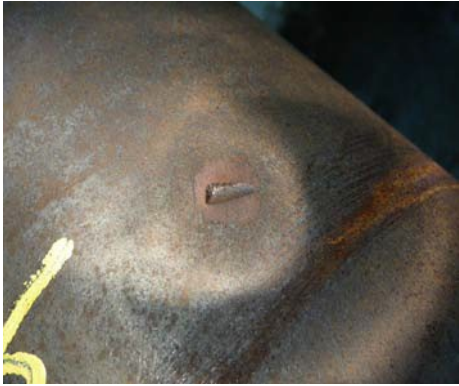
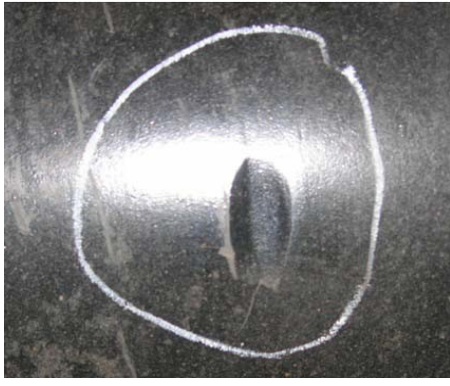
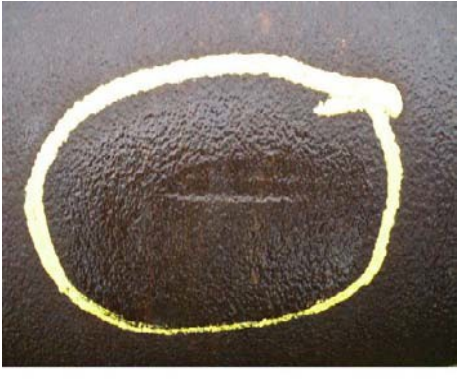
Pictorial representation:

33 Mechanical damage – sharp edged notching		Painted axles
Salient information:		
	Sharp edged notches occur locally and are characterised by sharp-edged transitions.	
	Mechanical damage to the base material in the form of notching is inadmissible.	
Decision:		
	Remove from service (according to GCU criteria)	
		Case A
		X

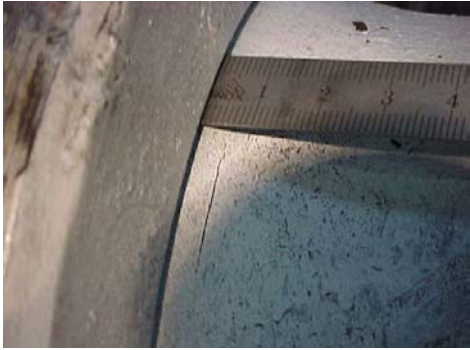
Pictorial representation:

34 Mechanical damage – cracks		Painted axles
Salient information:		
	Cracks occur locally on the shaft material (not on the painting) and are characterised and visible by fine lines.	
	Mechanical damage to the base material in the form of cracks is inadmissible.	
Decision:		
	Remove from service	Case A
		X

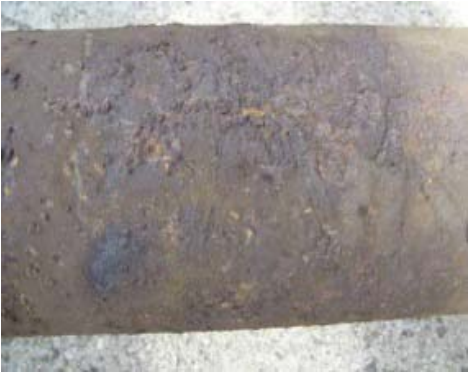
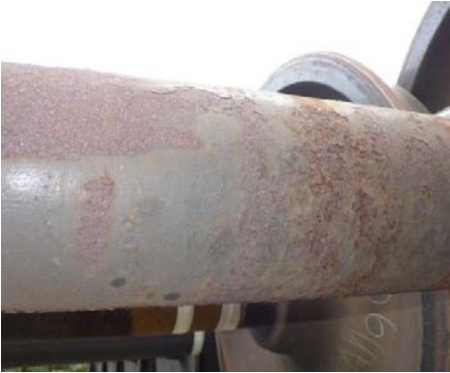
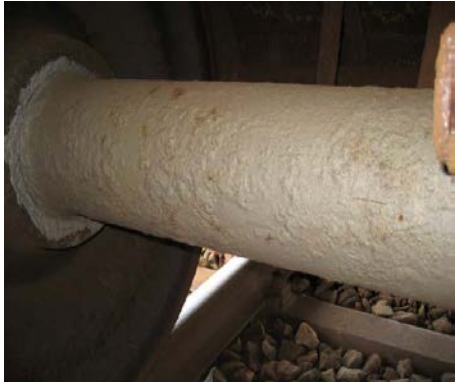
Pictorial representation:

35 Surface damage – large and heavily corroded areas		Painted axles
Salient information:		
	Surface damage to base material in form of large and heavily corroded areas (old corrosion protection) is inadmissible.	
Decision:		
	Remove from service	Case B
		X

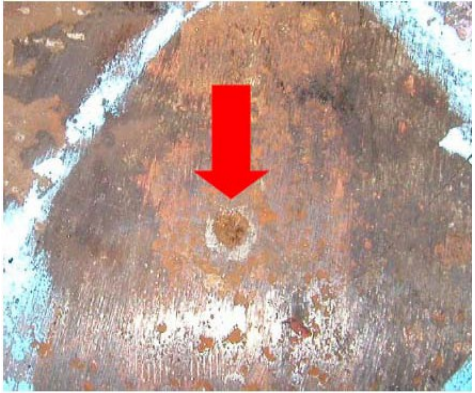
Pictorial representation:

36 Surface damage – single, deeply pitted corrosion scars		Painted axles
Salient information:		
	Surface damage to the base material in the form of marked, local corrosion scars (resulting e.g. from chemical effects) is inadmissible.	
Decision:		
	Remove from service	Case B
		X

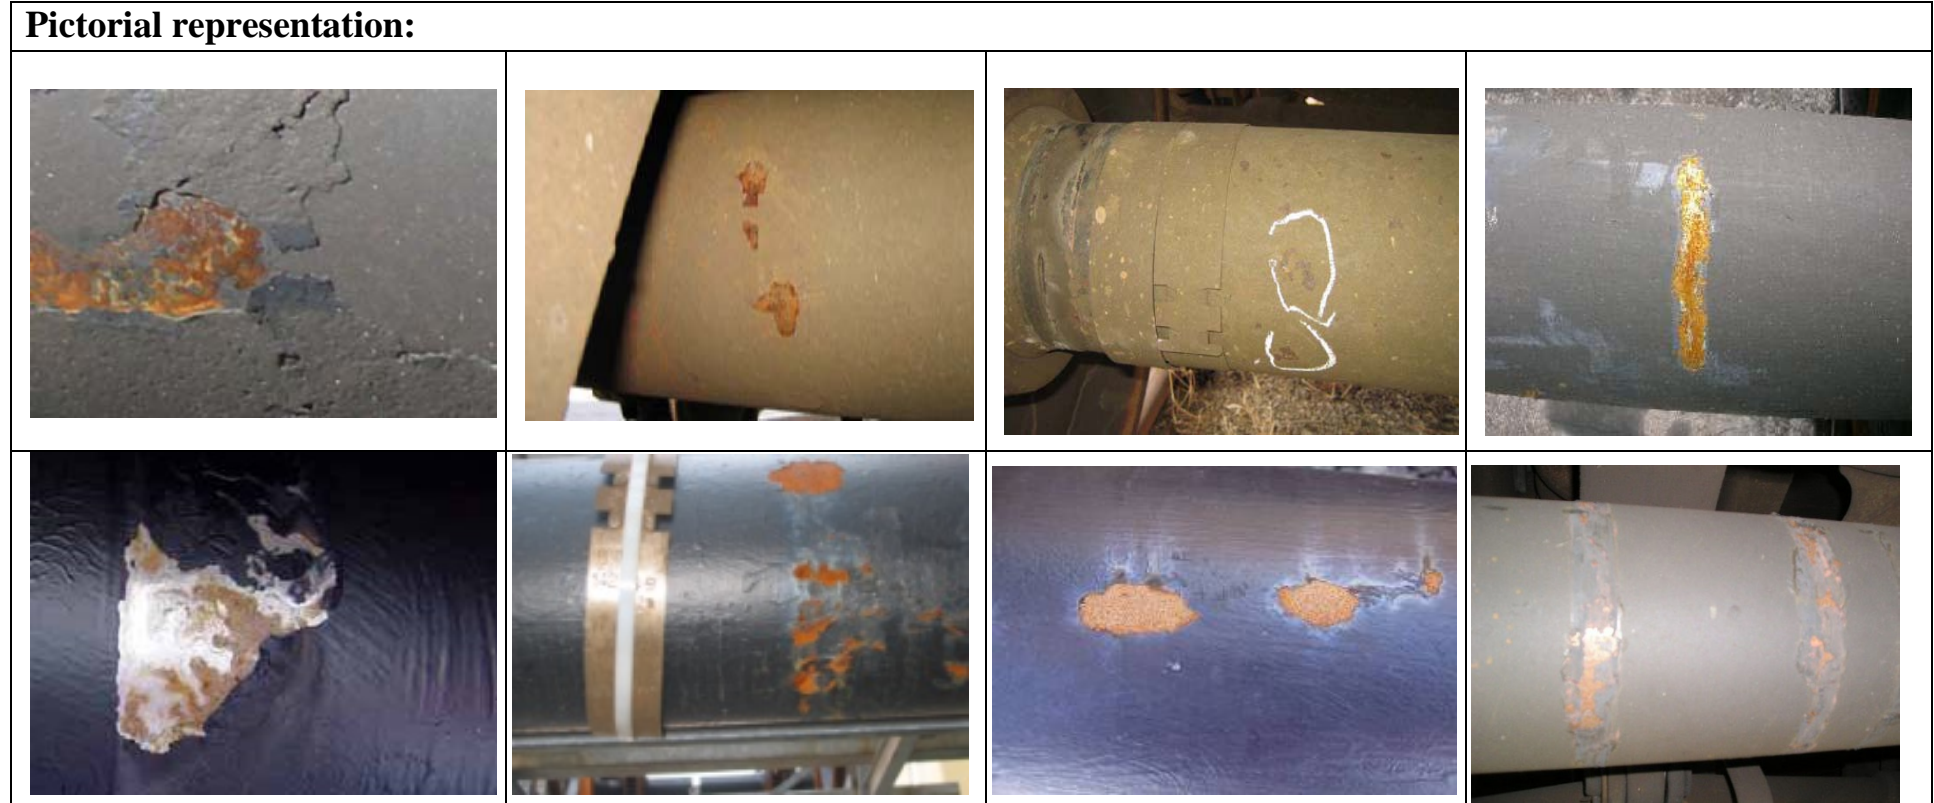
37 Coating damage – with or without corrosion		Painted axles
Salient information:		
	Minor lack of an anti-corrosion coating, whether corrosion is involved or not.	
Decision:		
	Leave in service acc. case C and/or repair the damage in situ on the wheelset	Case C
		C

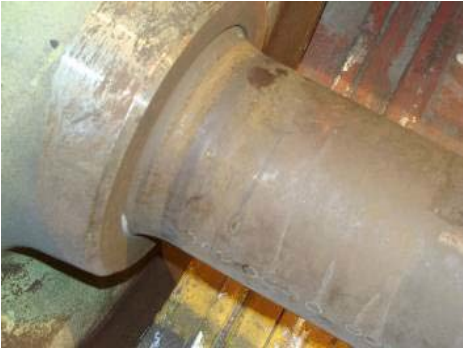
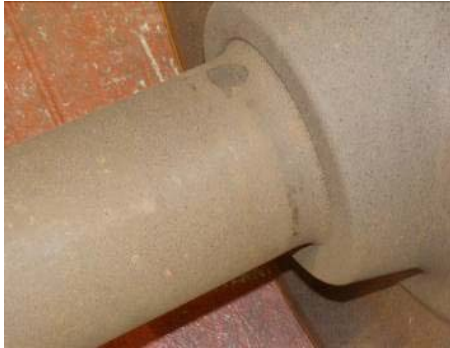
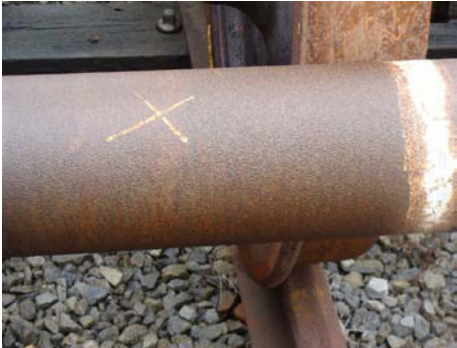
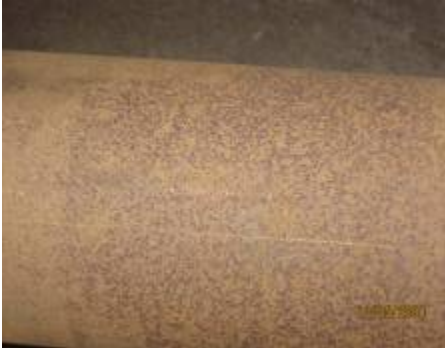
40 No defect - admissible surface appearance		Unpainted axles
Salient information:		
	There exist maintenance rules that do not require any anti-corrosion protection. Axles and wheels stay unpainted in such cases and show a thin and uniform layer of rust on their surfaces in service.	
Decision:		
	Deep corrosion is not accepted.	
	Leave in service wheelset “as new”, “very good”, “good” and “acceptable”	
		OK

Pictorial representation:			
As new	Very good	Good	Acceptable

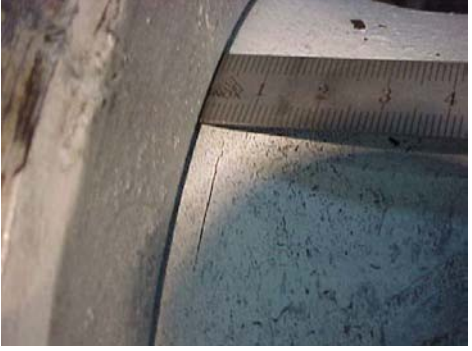
Pictorial representation:

44 Mechanical damage – cracks		Unpainted axles
Salient information:		
	Cracks occur locally and are characterised and visible by fine lines.	
	Mechanical damage to the base material in the form of cracks is inadmissible.	
Decision:		
	Remove from service	
		Case A
		X

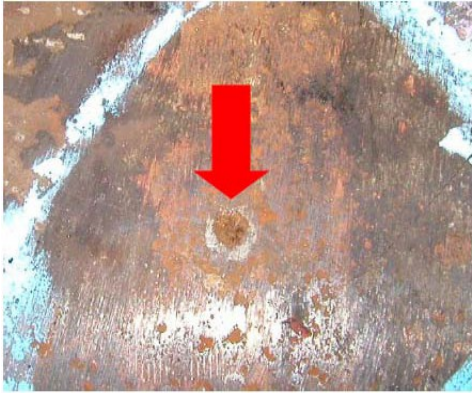
Pictorial representation:

46 Surface damage – single, deeply pitted corrosion scars		Unpainted axles
Salient information:		
	Surface damage to the base material in the form of marked, local corrosion scars (resulting e.g. from chemical effects) is inadmissible.	
Decision:		
	Remove from service	Case B
		X
